Manhole Inspection Summary

Manhole # S21C__031MH

Insp Date: **9/18/07 11:10 AM**

Location Address: **1637 EDMONDSON-ALLEY-FRANKLIN** Cross Street: **MOUNT ST**

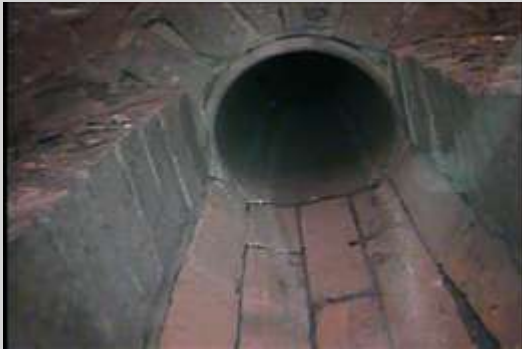
12 O'Clock Outflow

8 in. Circular Gravity Sewer
Pipe Out @ 12 O'Clock

Pipe Height: **8.4** (in.) Rod and Bar (Angled)
Pipe Material: **Clay** ☐ Pipe Lined
Invert Depth: **9.36** (ft.) Flow Characteristics: **Slow**
Deposits: ☒ None ☐ Mud ☐ Sludge ☐ Debris ☐ Grease
Silt Depth: (in.) Deposits Extent:
Infiltration: **None** Pipe Seal Cond: **Sound**

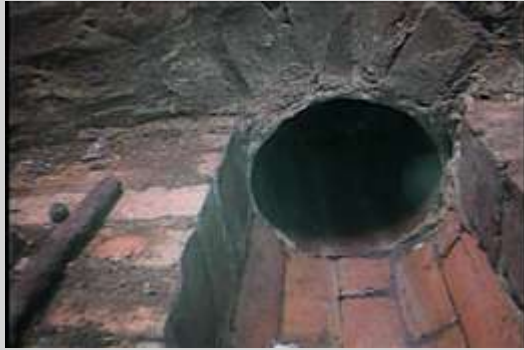
6 O'Clock Inflow

8 in. Circular Gravity Sewer

Pipe In @ 6 O'Clock

Pipe Height: **8.4** (in.) Rod and Bar (Angled)

Pipe Material: **Clay** ☐ Pipe Lined

Infiltration: **None** Pipe Seal Cond: **Sound**
